**UNDER WHITLE FARM,
SHEEN
STAFFORDSHIRE**

Report on the excavation of Trench 2

**TPA Project Code – UWC
TPA Report No. 077/2016**

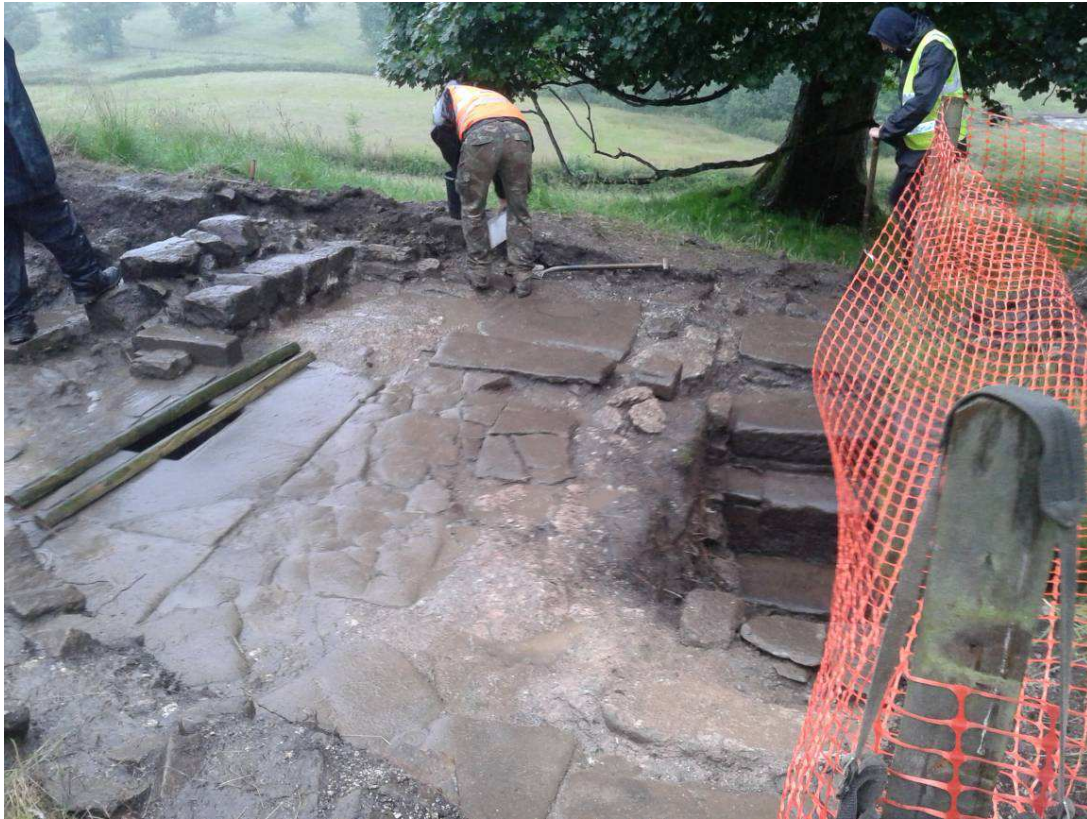
Plate 1: General view of the northern room under excavation, viewed looking north.

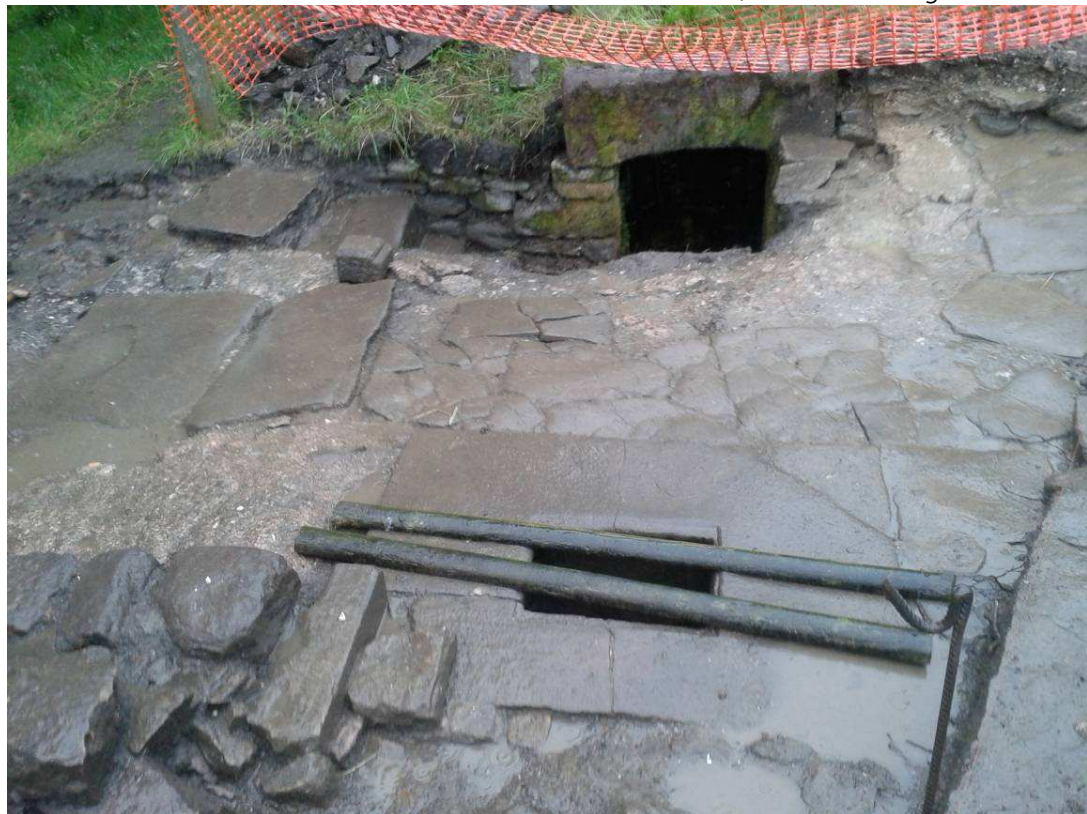
Plate 2: General view of the northern room, viewed looking south-east. Note the later stone flag at the top of the cellar steps and the re-used stone arched lintel leading into the cellar.

5.1.6 The steps to the cellar led down from the south-east corner of this room turning through 90 degrees at the bottom to pass under an arched stone lintel into the cellar to the south. The stairway was 0.72m in width with steps formed of stone blocks up to 0.3m deep (129). The steps were somewhat irregular in tread depth and rise height, varying from 0.28-0.37m for the former and between 0.12m and 0.37m for the latter. In the wall opposite the steps at the bottom was a small recess, c. 0.3m x 0.2m by at least 0.15m deep. Some 0.8m of fill was removed from the stairway but a similar amount at least probably remains to a depth which would allow easy passage under the stone lintel.

6.3 Following the collapse and robbing of the house the cellar was re-used, its size suggesting that it was probably an agricultural storeroom rather than a workshop. The barrel vaulted roof was inserted as it can clearly be seen abutting the earlier cellar walls to north and south. A lintel was also re-used and placed over the cellar's north entrance. An extra flag was added to the top of the steps in the northern room. It is likely that at this time the cellar window was converted into a doorway.

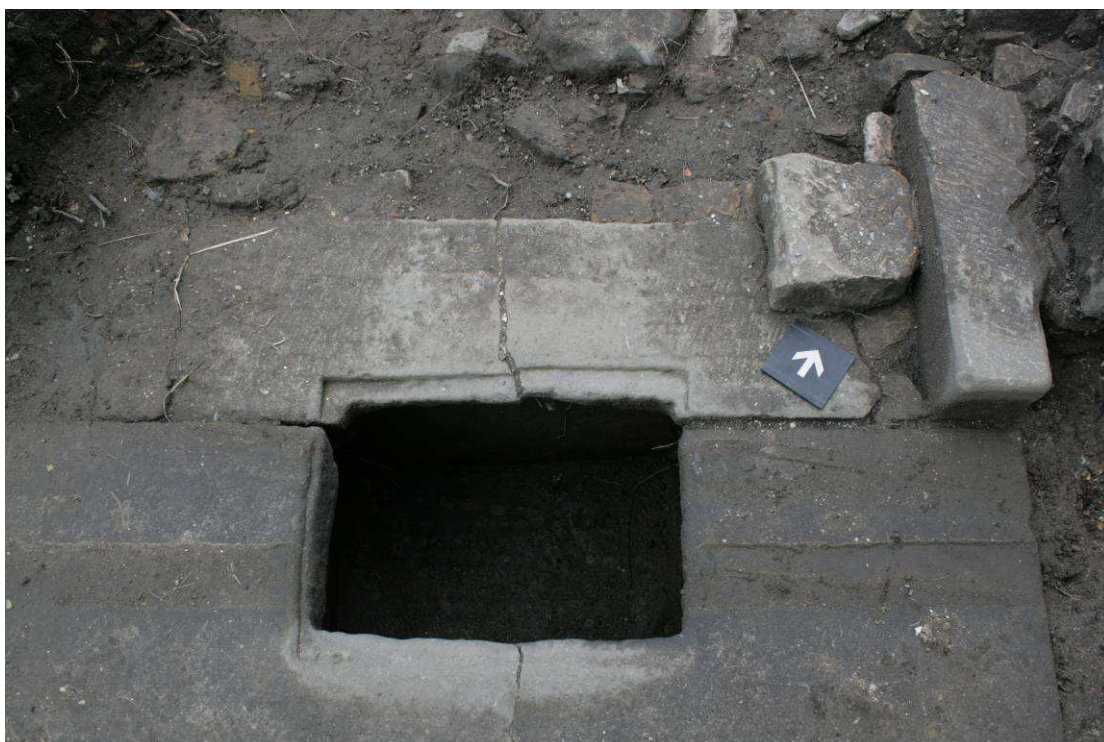
Plate 3: The ash pit and east base of the fireplace surround in the north gable wall, viewed looking north-west.

6.2 The partially excavated two-unit house is stone built with quoins, the width of the walls indicating that it was two to three storeys in height. Stone roof flags were recovered from the rubble overlaying the site suggesting that the building was roofed in stone. It has a fireplace in the north gable wall. The northern room has a stone flagged floor with an ash pit to the south of the fireplace. In the south-east corner is a set of stairs leading down to the entrance of the cellar that extends beneath the southern room. The opening for the cellar stairs would originally have been covered with a trap door. In the west wall of the stair well, by the doorway into the cellar, is a niche for a candle or taper. It is likely that the entrance into the northern room was via a door in the west wall opposite the steps into the cellar with a door to the west of the cellar stairs providing access between the two rooms. The southern room would have had a timber plank floor over the cellar. A window in the south gable, later perhaps converted into a doorway, provided light into the semi-subterranean cellar. The width and depth of the stonework abutting the north gable wall is suggestive of a single storey extension.

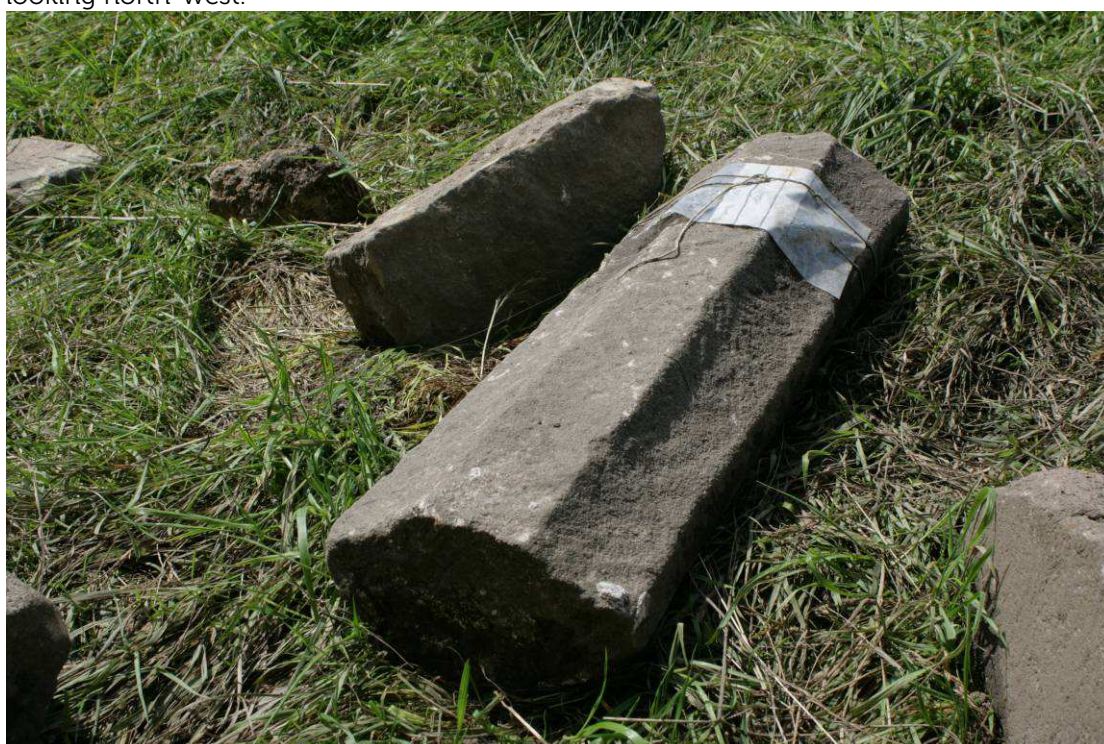
Plate 4: The chamfered flat splay mullion recovered from rubble deposit (112).

6.4 A number of stone architectural pieces were recovered from the excavation including a chamfered flat splay mullion, a type found in other houses within Derbyshire dating to between 1615 and 1763 (Alcock and Hall 2002, 38). Fragmentary remains of a bolection moulded fireplace mantle was also recovered which is likely to date to the late seventeenth or early eighteenth century.

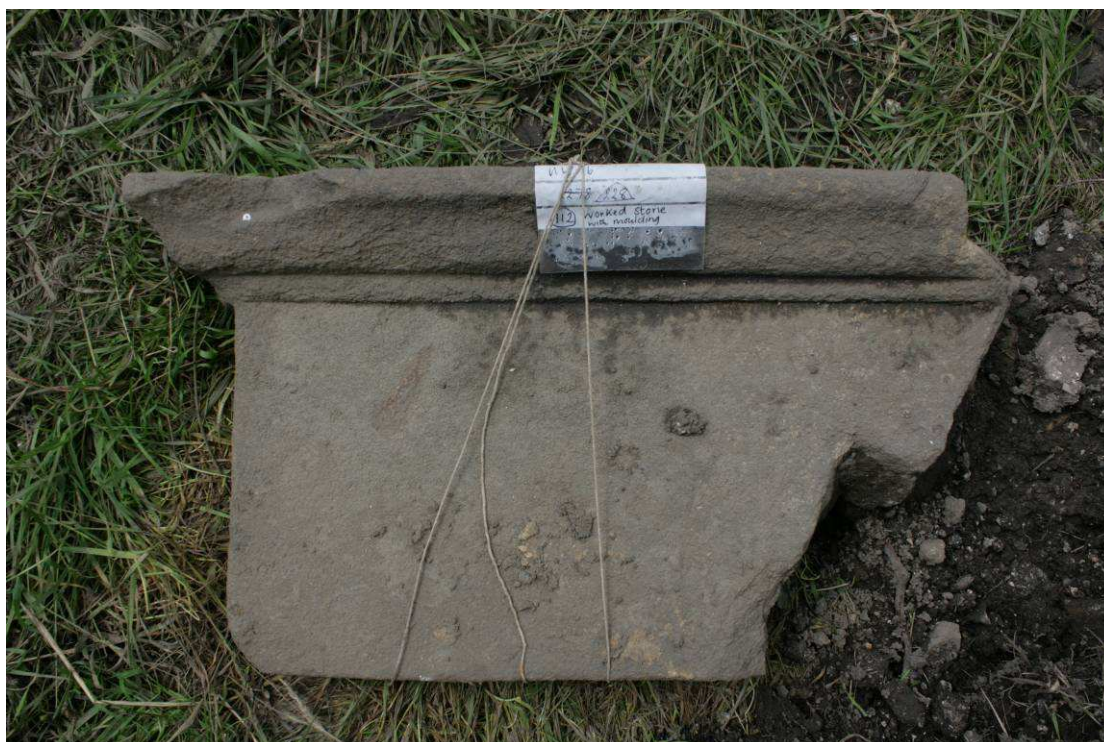
Plate 5: The moulded fireplace mantle recovered from rubble deposit (112).

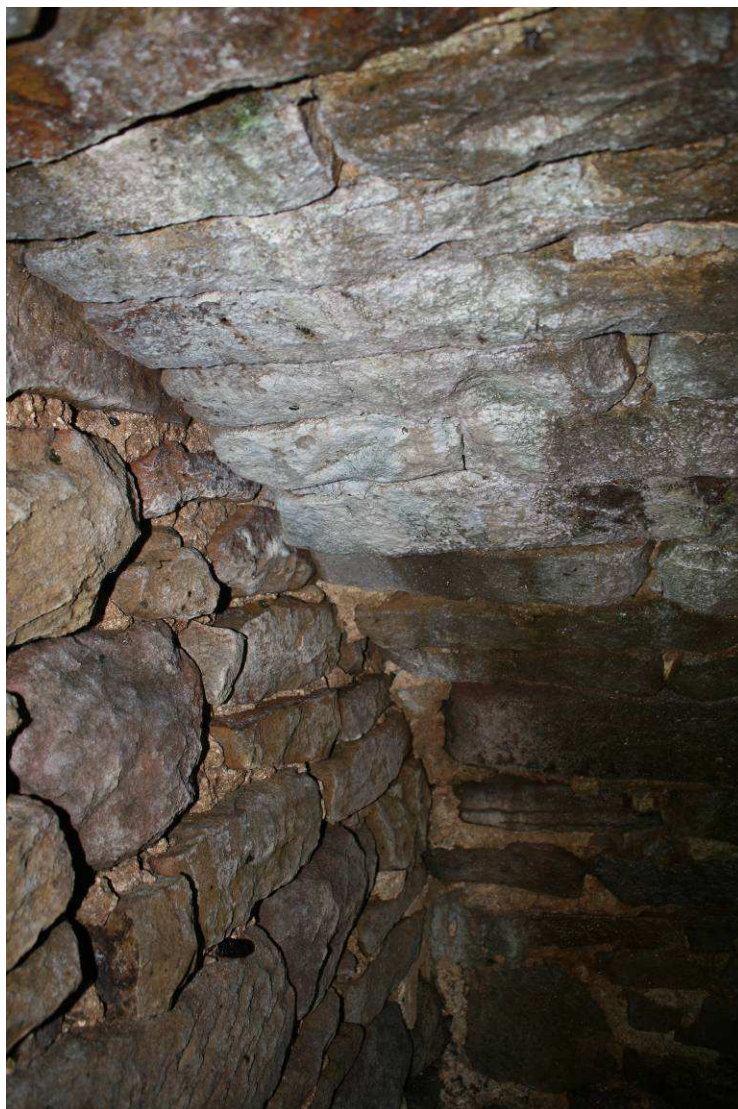
Plate 7: The barrel vaulted roof of the cellar abutting the earlier south gable wall.

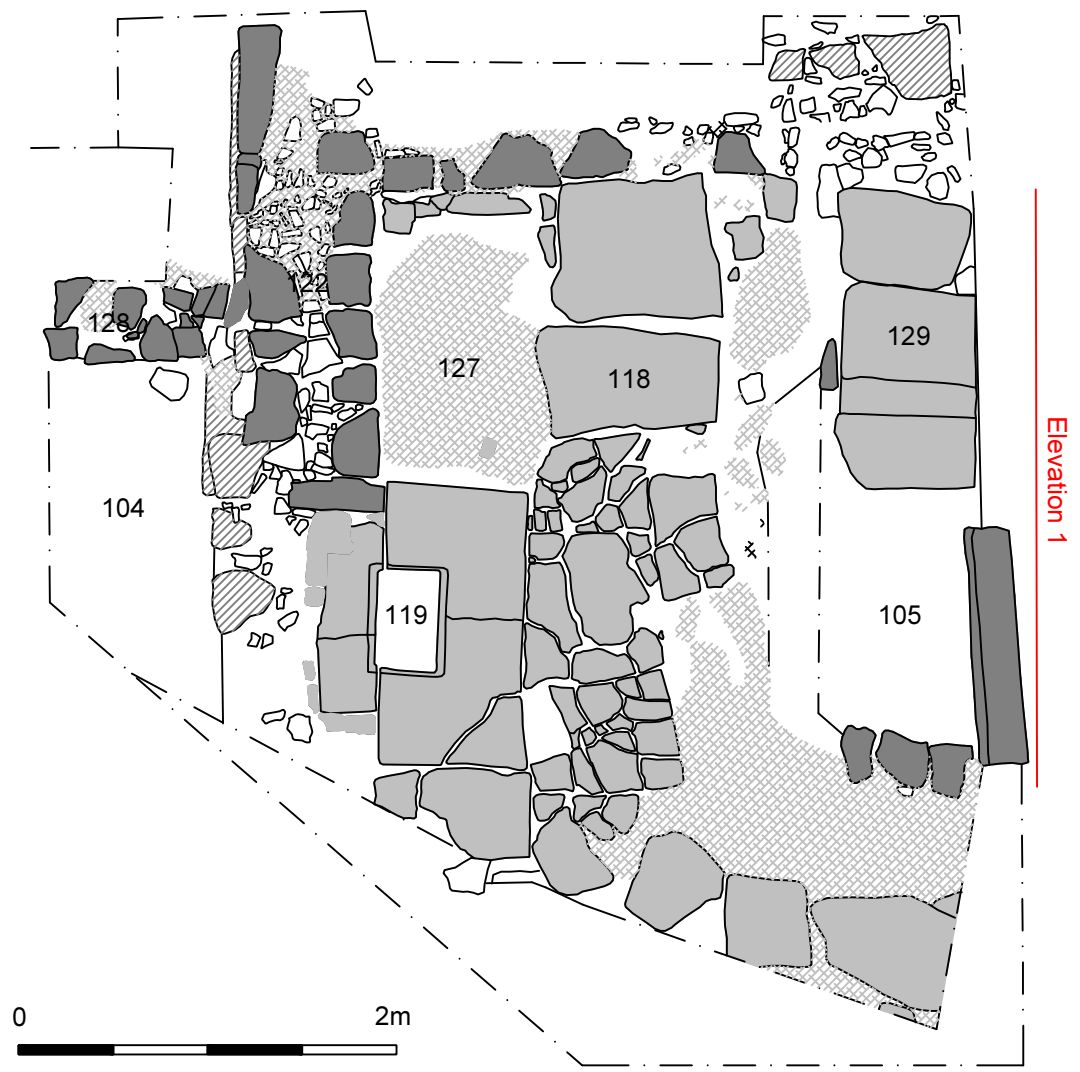
Figure 4: Trench 2 structural remains

5.1.4 Beneath stone rubble (112) remains of wall foundations and a floor surface were uncovered just to the north of the cellar steps. The walls (122) were 0.6-0.65m in width, of block in course masonry with a dressed quoin evident at the northern corner. Two wall courses survived where best preserved on the outer edge of the northern gable, but only a single course otherwise, rising off an offset foundation at least 0.9m in width (but the full depth of which was not revealed). The floor surface (118) was of large stone slabs, up to 0.8m x 0.7m, laid on a bed of mortar (127). In the south-western quarter of the room the slabs were broken into smaller pieces, but apparently still *in situ*. Recessed into the northern gable end wall was the base of a fireplace floored with similar slabs, but incorporating a rectangular ash pit (119), 0.55m x 0.35m and c.0.5m deep with a moulded rim (presumably once holding the grate, a fragment of which was retrieved from the base of the pit). The ash pit contained burnt deposits (120), (123) incorporating fragments of coal, presumably a remnant of last use. The room thus defined was 3.22m in width and at least 4.44m long (up to 4.8m if the central fireplace within the northern gable is included).

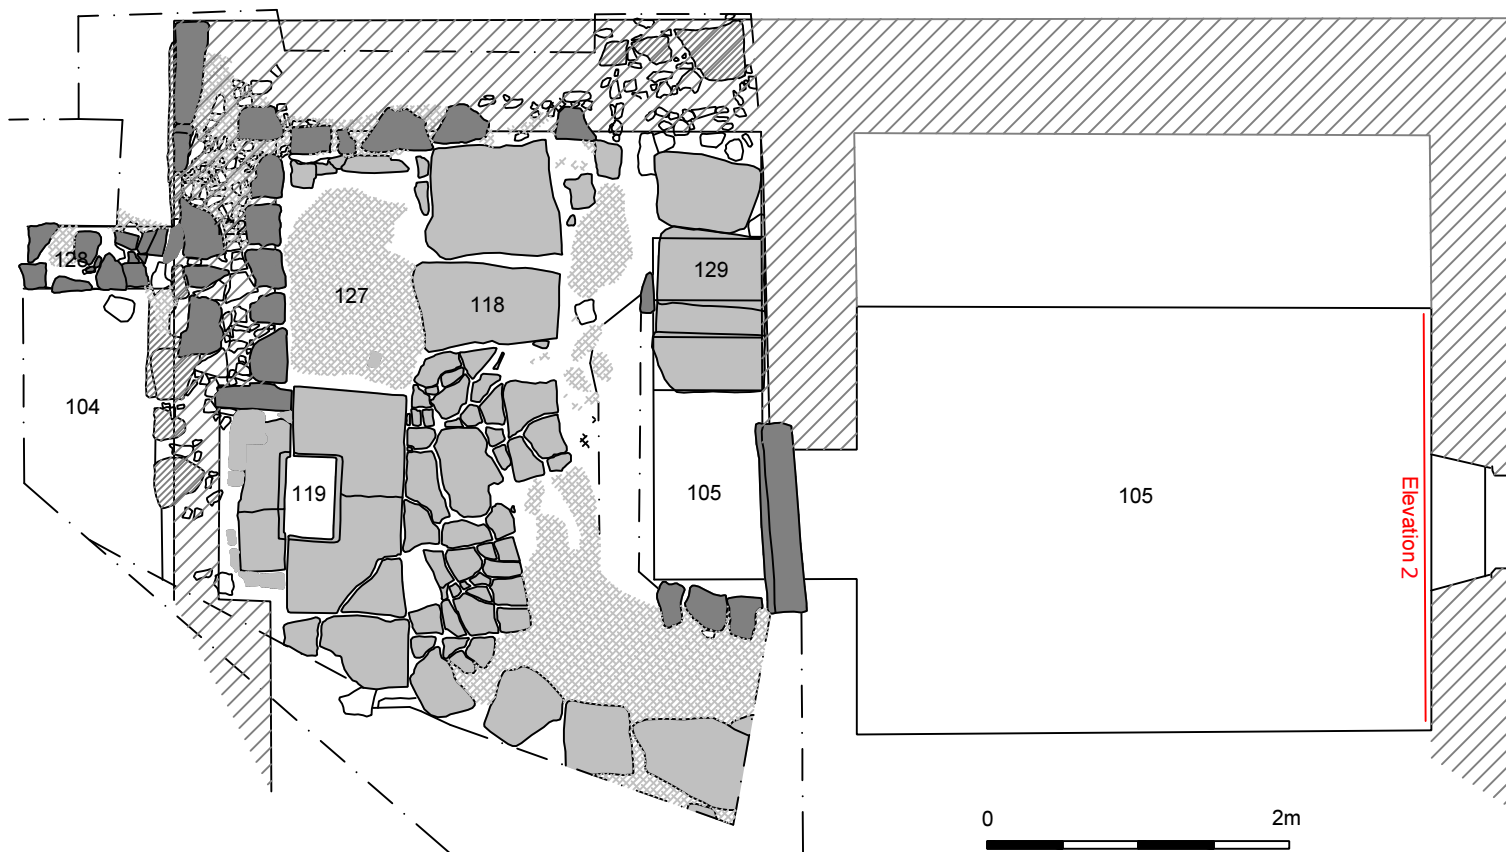
Figure 6: Trench 2 structural remains showing extent of cellar and conjectured wall lines
